**UNITED STATES AIR FORCE
ARMSTRONG LABORATORY**

**463L PALLET AND DUNNAGE SYSTEM
EVALUATION**

October 1997

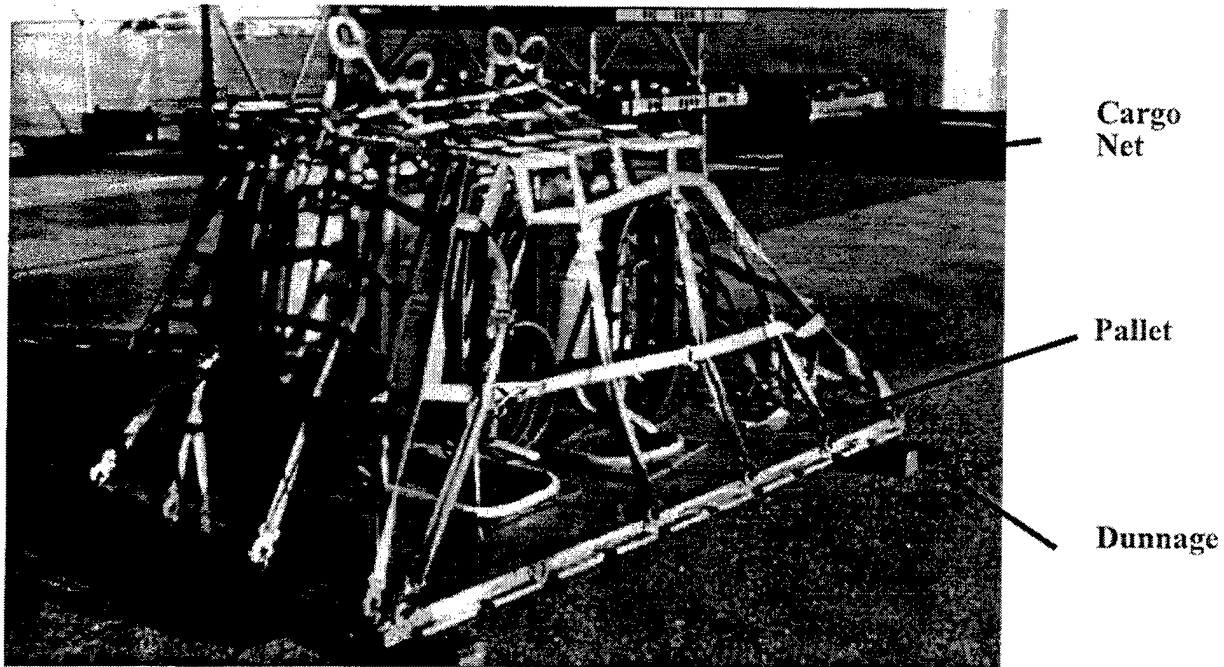
The 463L Pallet System consists primarily of the 463L pallet, dunnage, cargo netting, plastic cover, forklift, k-loader, aircraft rail system, and manpower. A combination of these components make up the entire system. Although, the concentration is on the pallet and dunnage, an understanding of all functional parts of the system and how they interact is important.

Figure 1: Loaded 463L Pallet

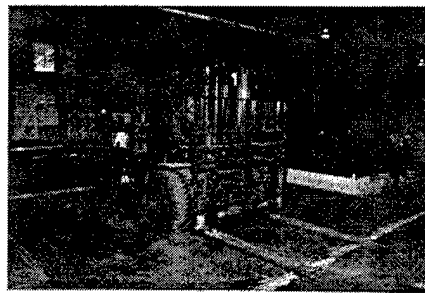
The forklift is used to carry a pallet (loaded or unloaded) between two locations and also to carry loads to and from a pallet. These are typically used in the build-up and break-down areas. Dunnage is placed under the pallet to allow the tines of the forklift to fit under the loaded pallet.

Figure 2: Forklift

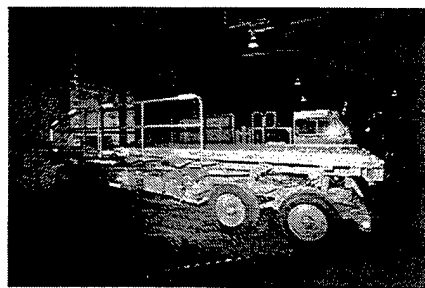
The K-loader is used to transport several pallets from the loading area to the aircraft. It contains a similar roller system to that of the aircraft's. The loader has the ability to carry the loaded pallets and lift them to the height required to push them into the aircraft.

Figure 3: K-Loader

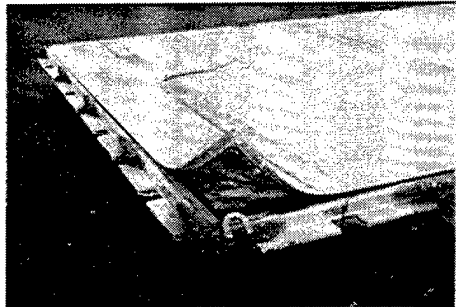
Personnel must be trained to detect the various types of pallet damage. Before building cargo up on the pallet, the pallet top and bottom should be checked for serviceability. The most common types of damage to the pallet are skin separation, skin punctures, warping, and missing or damaged D-rings. Any time damage is found, the pallet cannot be used to ship cargo. Instead, it is tagged and moved to the damaged-pallet staging area. Whenever the aerial port accumulates at least 10 damaged pallets, they will ship the pallets back to their regional hub (Travis AFB, Dover AFB, etc.). When the hubs accumulate approximately 120 damaged pallets, they will ship them back to the manufacturer for repair.

Figure 11: Pallet Skin Separation

Improper storage facilities, coupled with the pallet materials, account for a majority of pallet problems. The thin aluminum skin is glued to the side frames to keep the internal materials dry and give strength to the pallet. The glue bonding often separates under the normal stress of use. This separation allows water to seep into the balsa wood core, which expands with great force when wet. This expansion causes the skin to separate from the pallet frame (see Figures 13 and 14). Besides allowing water to seep in, outdoor storage near an ocean allows the salt air to corrode the pallet surfaces. Additionally, if nets are subjected to moisture, they must be thoroughly dried to prevent them from rotting.

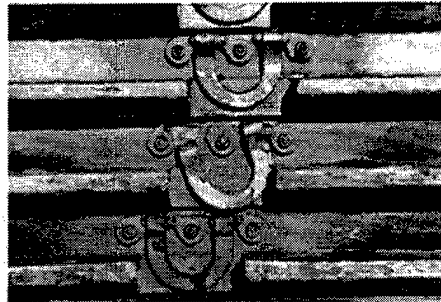
Figure 10: Damaged D-rings

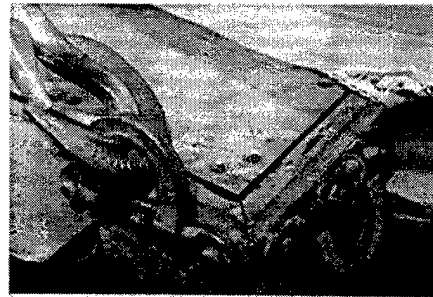
Figure 14: Pallet with Skin Separation

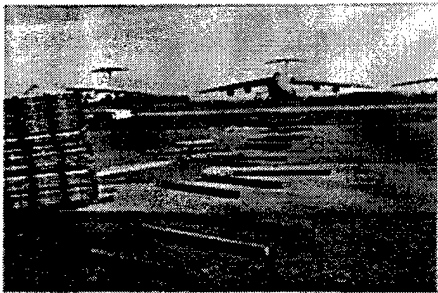
In the larger aerial ports, a large area will be semi-permanently set up for storage of transient pallets, referred to as the marshalling or staging area (Figure 15). These areas are often relatively flat blacktop lots where rows of dunnage (groups of 3 pieces appropriately spaced on the ground) are laid out on the ground. These pieces of dunnage are continually exposed to sun, rain, snow, heat, cold, etc., all of which deteriorates them. In addition, fork-lift trucks may run into the dunnage, splintering and breaking the wood (especially at night when the dunnage is hard to see.)

Figure 15: Marshalling Area

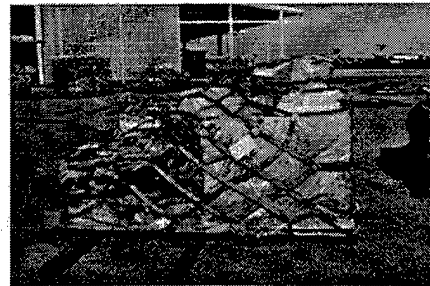
Figure 16: Wood Dunnage as Protective Flooring

Dunnage may also be used to distribute cargo weight, provide protective flooring, stabilize equipment, and build equipment ramps to aircraft. Wood used for these purposes is called "shoring". Dunnage is often diverted for shoring purposes and then not returned for dunnage use.

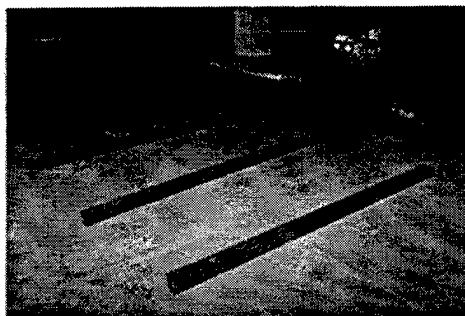
The ReNew pieces are made of a polyolefin-based plastic lumber called Perma-Poly™. A complete evaluation of Perma-Poly™ was carried out at Battelle Memorial Institute's

Industrial and Commercial Development Division, Polymer Product Center, in Columbus, Ohio. Appendix D contains the complete study plan, test procedures, and test results. The results are presented in a way that could be interpreted for application to other types of plastics suitable for dunnage. It should be noted that Black Rhino Recycling, Inc. currently has plastic lumber in various shapes and sizes available through government supply channels. Some aerial ports have already begun to use Black Rhino's 4"x4"s as dunnage.

Figure 19: ReNew Plastic Dunnage

The material property analysis found the plastic lumber to be essentially the same as or better than the wood in all cases except two: agent decontamination and density. After exposure to chemical warfare agents, decontamination may be more difficult for plastic than for wood. This scenario would be true if the contaminated dunnage needs to be disposed of. Wood is easily disposed of by burning. The polyolefin will also burn, but takes much longer. The plastic's higher density makes each piece significantly heavier than wood. A 4"x4"x88" piece of wood weighs around 15-20 lbs, compared to 25-30 lbs for the Perma-Poly™. However, Black Rhino also makes a hollow core dunnage which weighs only 13 lbs. Unfortunately, due to the limited scope of this task, the hollow piece was not analyzed for this study.

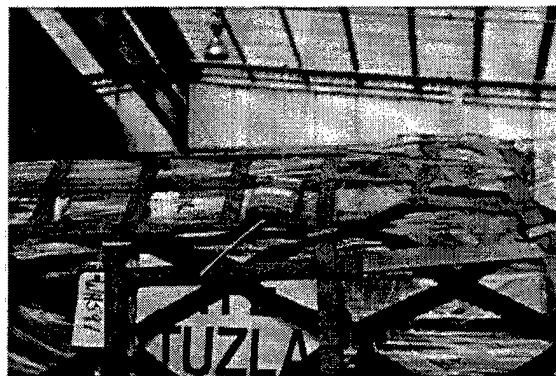
The US Army has a pilot program using SAVI technology that allows for the tracking of the pallet and its cargo. The Air Force is monitoring this program to determine its effectiveness. Other tracking methods currently used should be researched to determine their applicability to Air Force cargo transportation needs and the Total Asset Visibility concept.

Figure 21: SAVI RF Tag for Tracking
